UNITED STATES ENVIRONMENTAL PROTECTION AGENCY
REGION IX
75 Hawthorne Street
San Francisco, CA 94105-3901

I am writing today to request information from the Navajo Tribal Utility Authority (NTUA) regarding events leading up to and following the recent bypass and unauthorized discharge of wastewater from the Window Rock Wastewater Treatment Lagoon (NPDES Permit No. NN0021555). Today's request for information is directed to you, as General Manager of NTUA, pursuant to section 308(a) of the Clean Water Act (CWA), 33 U.S.C. § 1318(a), which authorizes EPA to require persons subject to the Act to furnish information, conduct monitoring, provide entry to the Administrator or authorized representatives, and make reports as may be necessary to carry out the objectives of the CWA.

RE: Potential Illegal Discharges at the NTUA Window Rock WWTF

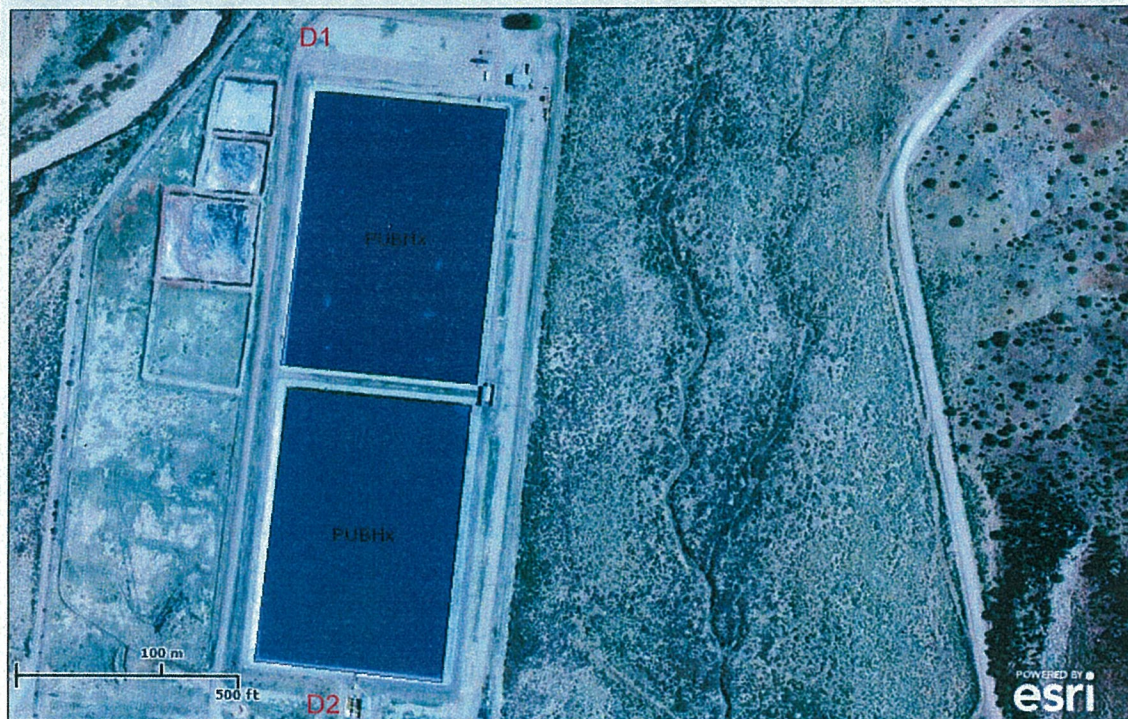
wr wwtp

Concerning the first potential discharge which occurred in the NW corner of the WWTF property (D1 on the attached aerial photo), Mr. Silversmith indicated that a potable waterline joint burst at the point where the WWTF taps into the NTUA waterline. This resulted in the pooling of water inside and outside the WWTF perimeter fence (Photograph Nos. 1 and 2). No waters of the U.S. were impacted. The waterline has been repaired.

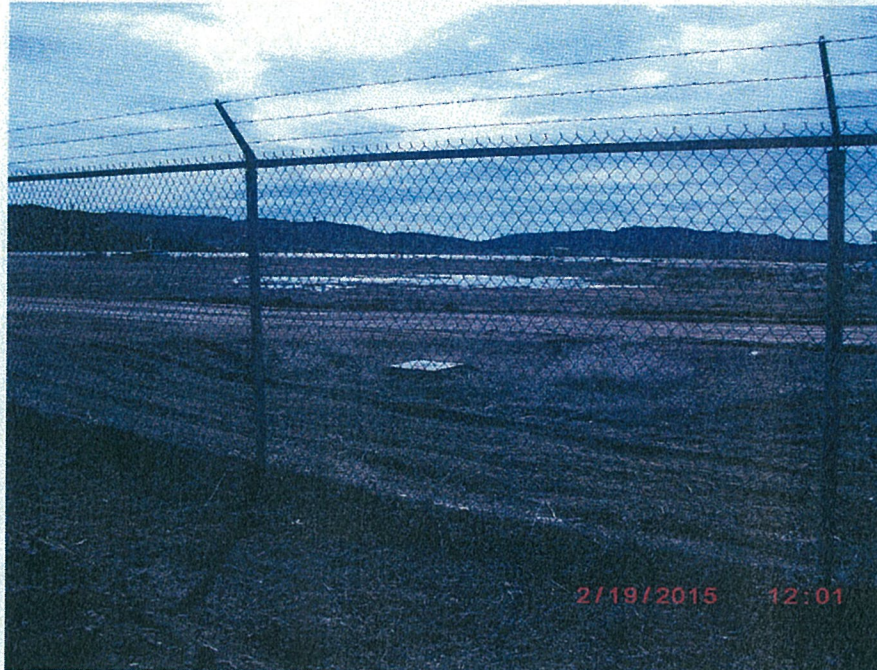
Photograph No. 1, SW/S view – Pooling of water within the NTUA Window Rock WWTF fence. The water was from a burst waterline which occurred just to the right. The water crossed the fence.

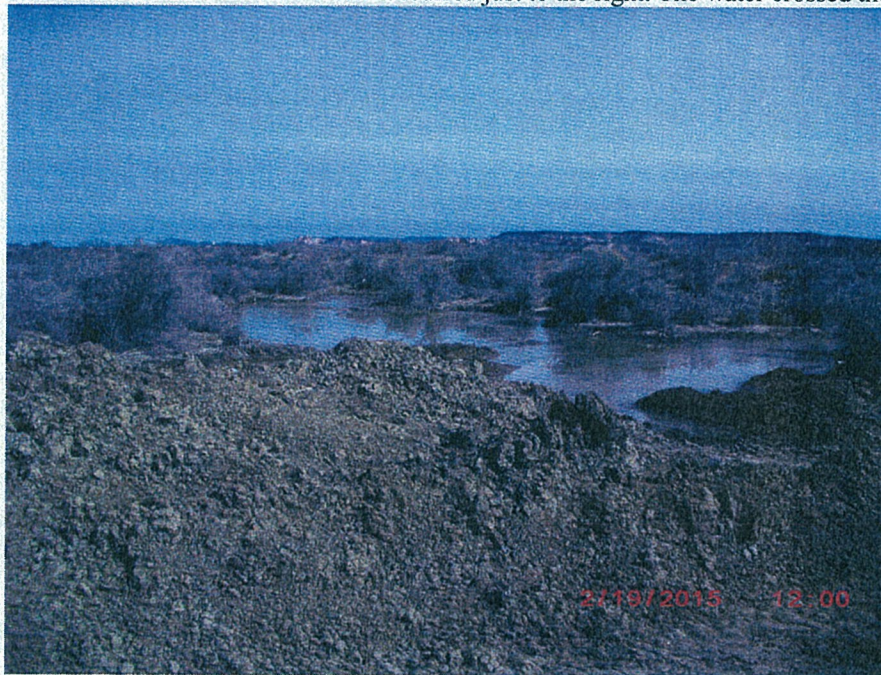
Photograph No. 2, N/NW view – Pooling of water outside the WWTF fence. NTUA graded through the pool to allow access for repair of the broken waterline.

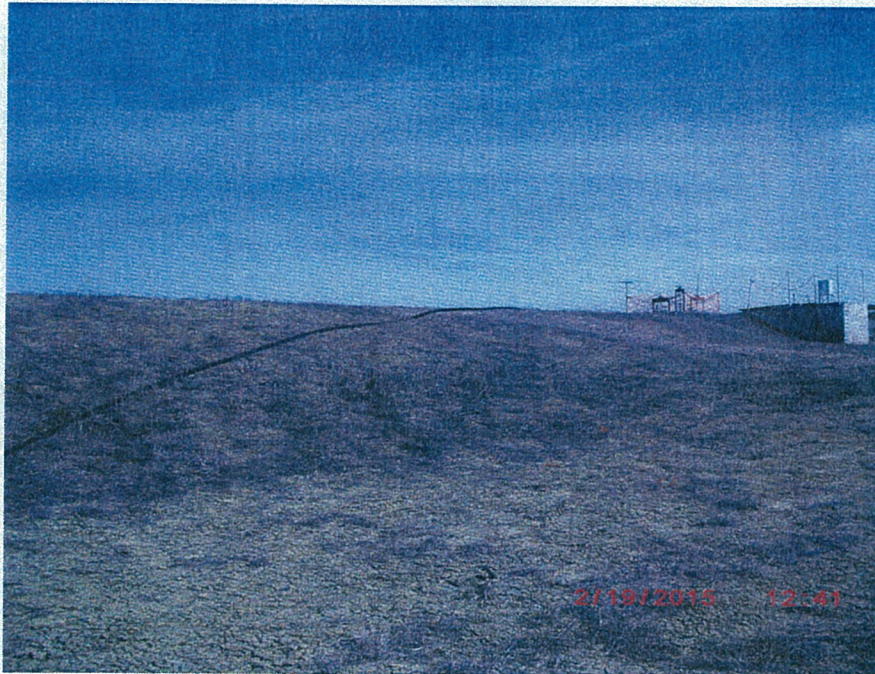
Photograph No. 5, NE view – The black plastic piping coming from the chlorination/algae screen pumps is redirected away from and south of the second lagoon.

Concerning the second potential discharge which occurred in the southern portion of the WWTF property (D2 on the aerial photo), Mr. Silversmith indicated that the black plastic piping running into the second cell from the chlorination building pumps was freezing up causing the effluent to buildup which shut off the pumps. As a result, the black plastic piping was redirected from going into the second lagoon to allowing wastewater to be released in an open area to the south but within the WWTF perimeter fence (Photograph Nos. 3-8). This would not appear to be a proper O&M technique, especially with the facility currently under a consent order.

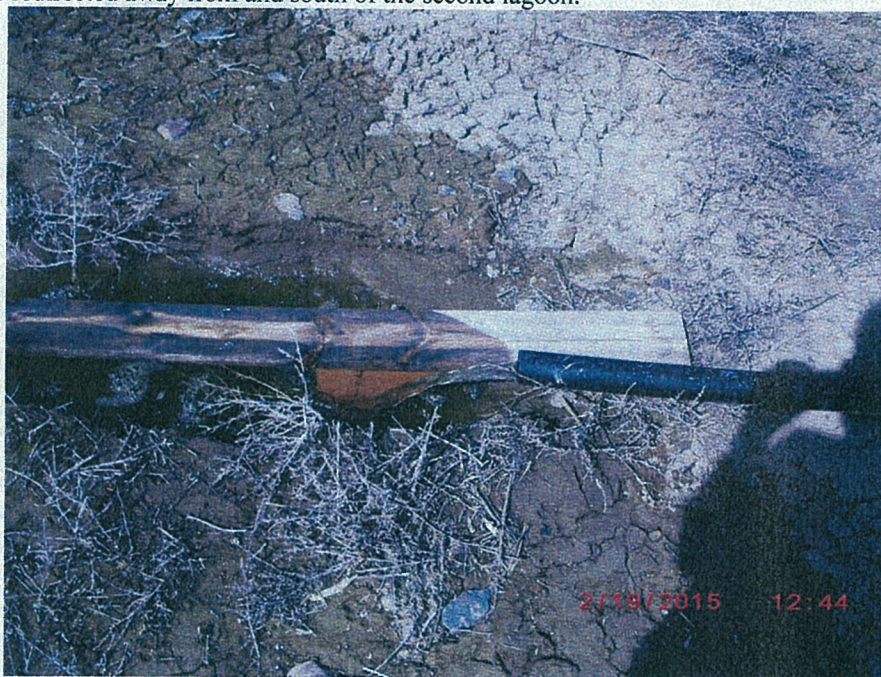
Photograph No. 6, NW/N view - The end of the black plastic piping coming from the chlorination/algae screen pumps. Wastewater being released onto a piece of board.

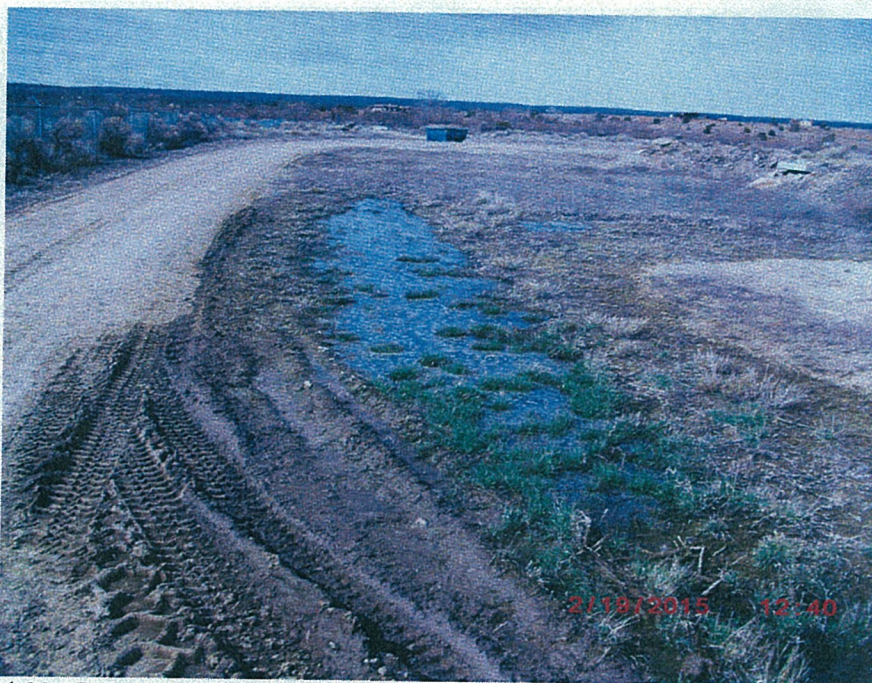
Photograph No. 7, W view - The pooling of wastewater from the black plastic piping coming from the chlorination/algae screen pumps. The southern WWTF fence is to the left.

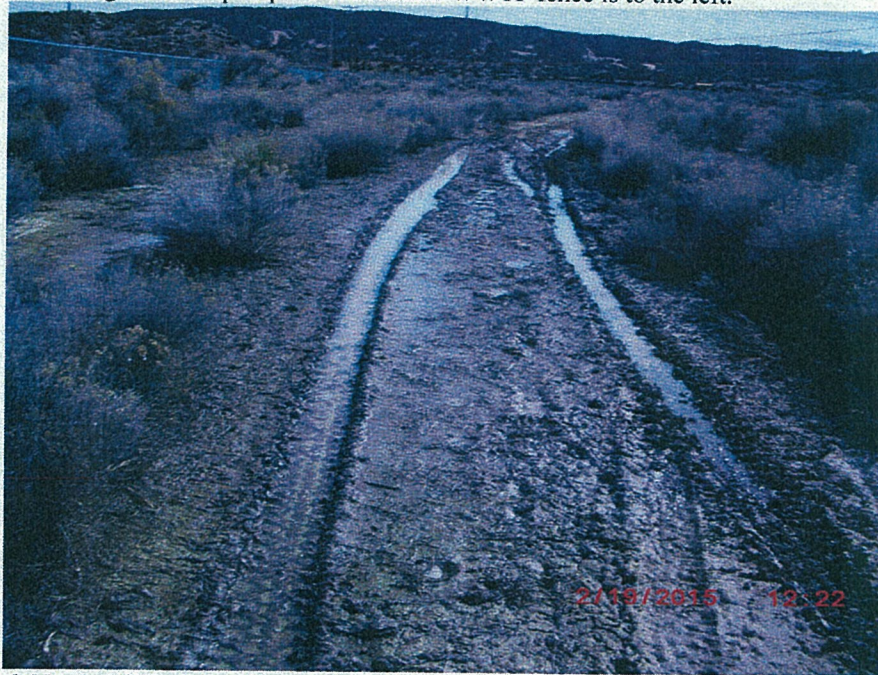
Photograph No. 8, E/SE view - The pooling of wastewater from the black plastic piping coming from the chlorination/algae screen pumps on a dirt road just outside and south of the WWTF fence.
